**Re: Upper Lynde Basin Dam - MA01308
Sterling, MA
Follow-up Inspection Report 8/10/18**

**- UPPER LYNDE BASIN DAM-
FOLLOW-UP INSPECTION REPORT**

Commonwealth of Massachusetts
Department of Conservation and Recreation
Office of Dam Safety Poor and Unsafe Condition Dam Follow-up Inspection Form

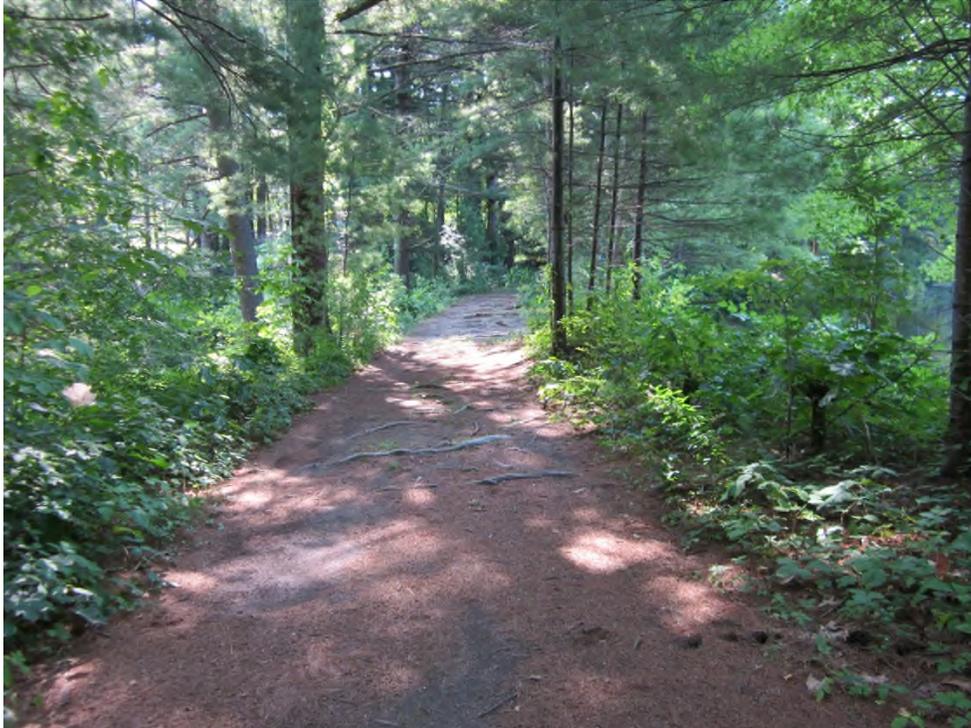
Photo 1 – Dam Crest viewed from left abutment

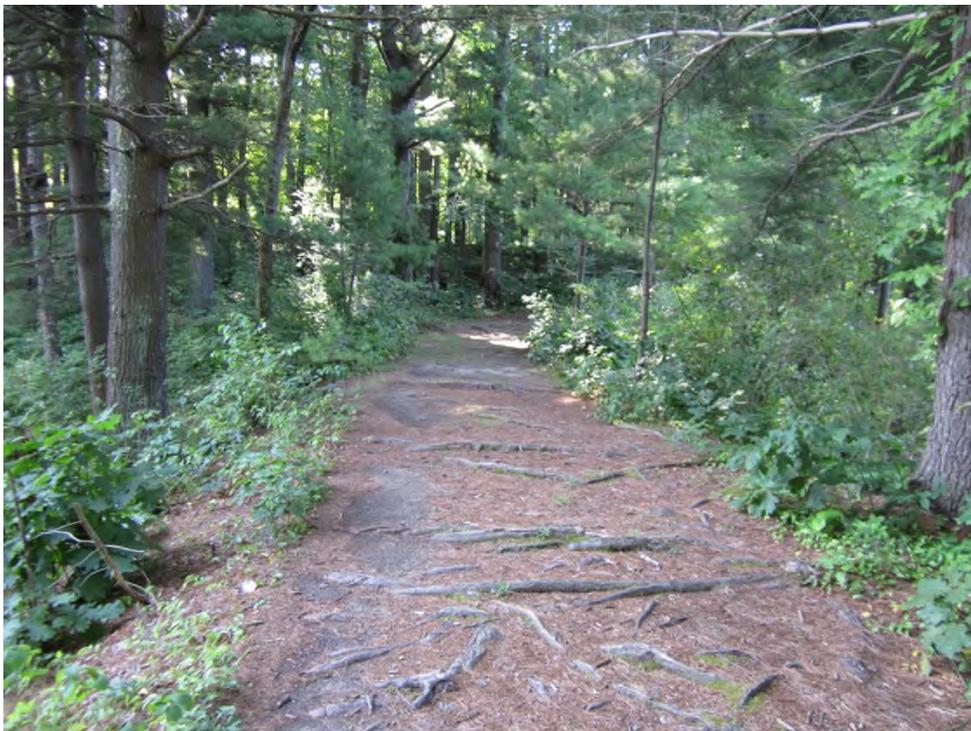
Photo 2 – Dam Crest at center of embankment

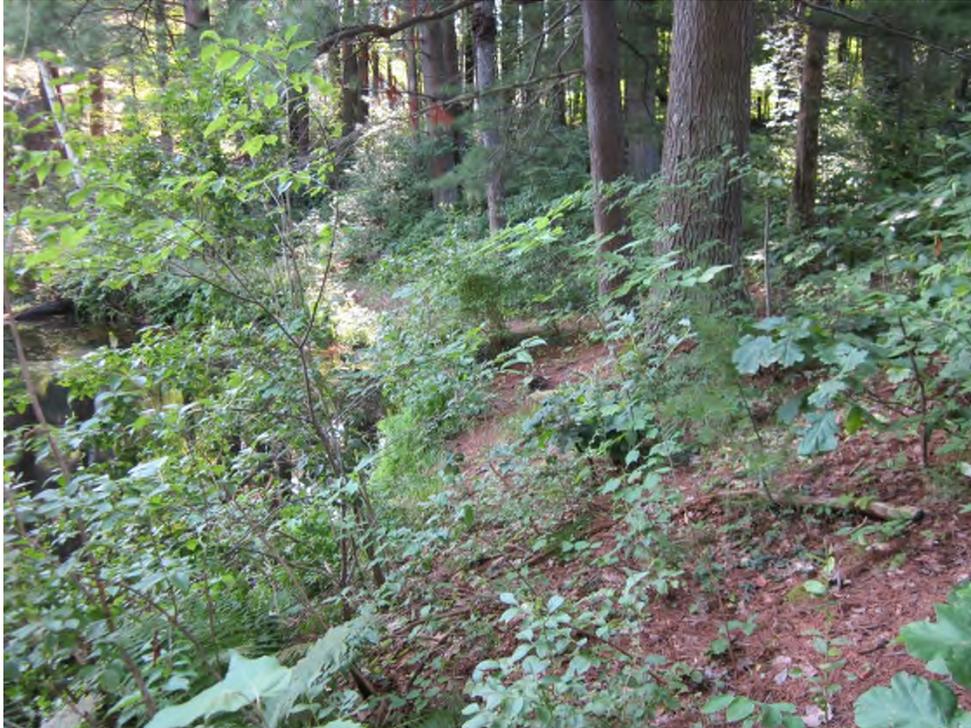
Photo 3 – Trees and vegetation on upstream slope (typical of entire slope)

- Clear all trees, woody and low vegetation from the dam and slopes including areas 20 feet from any part of the structure.
- Make temporary repairs to the spillway..
- Perform a detailed follow-up inspection of the dam to identify all deficiencies and maintenance items.

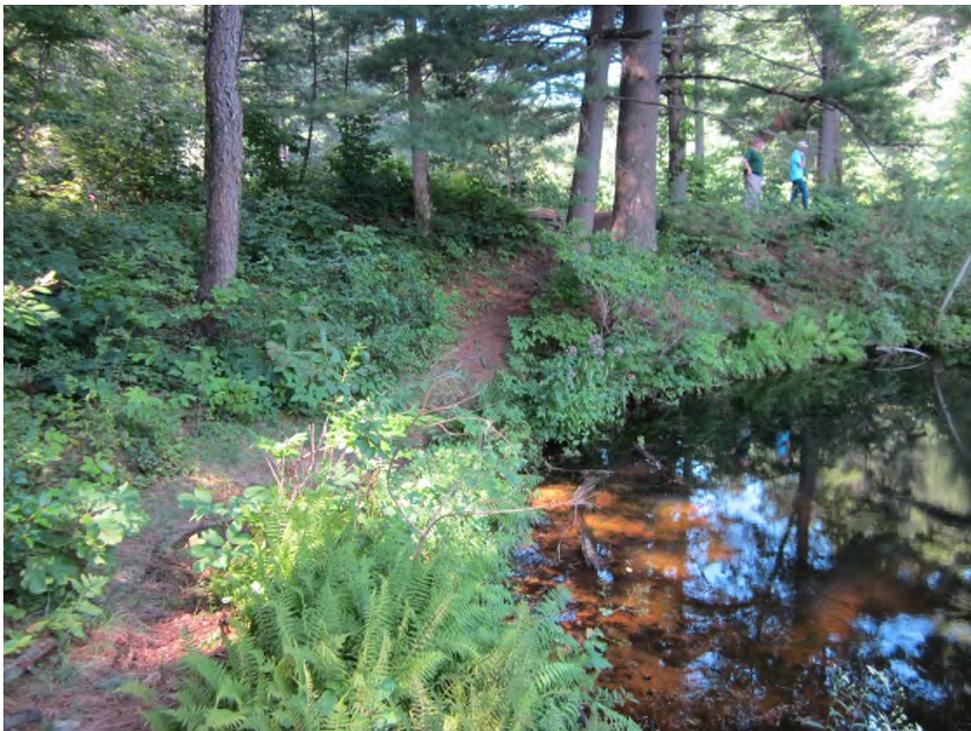
Photo 4 – Trees and vegetation on downstream slope at right abutment

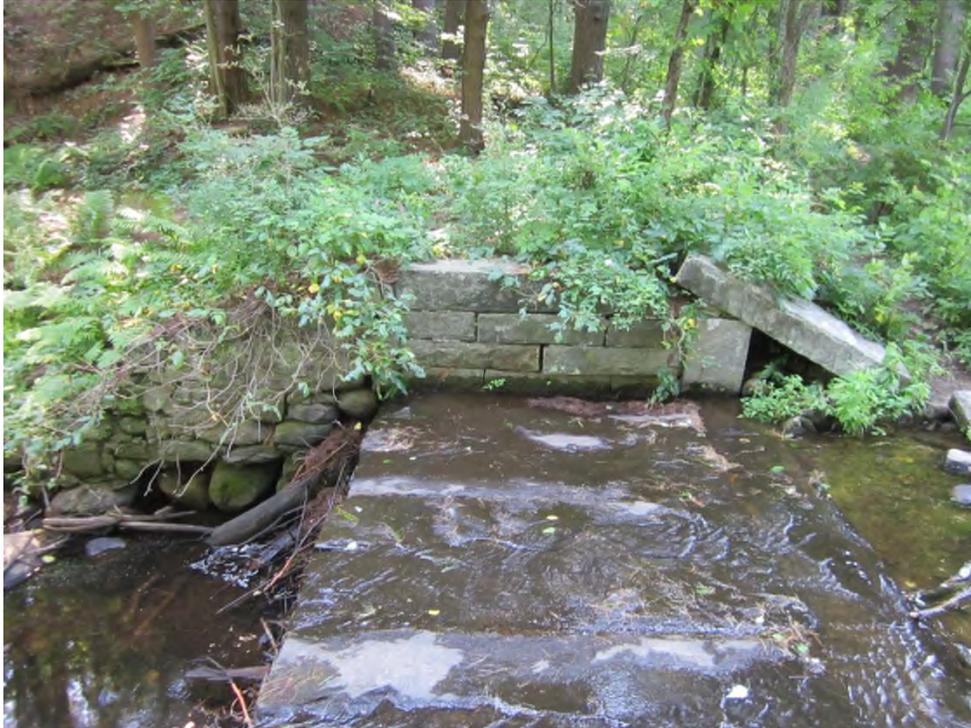
Photo 5 – Spillway crest, right training wall and right abutment

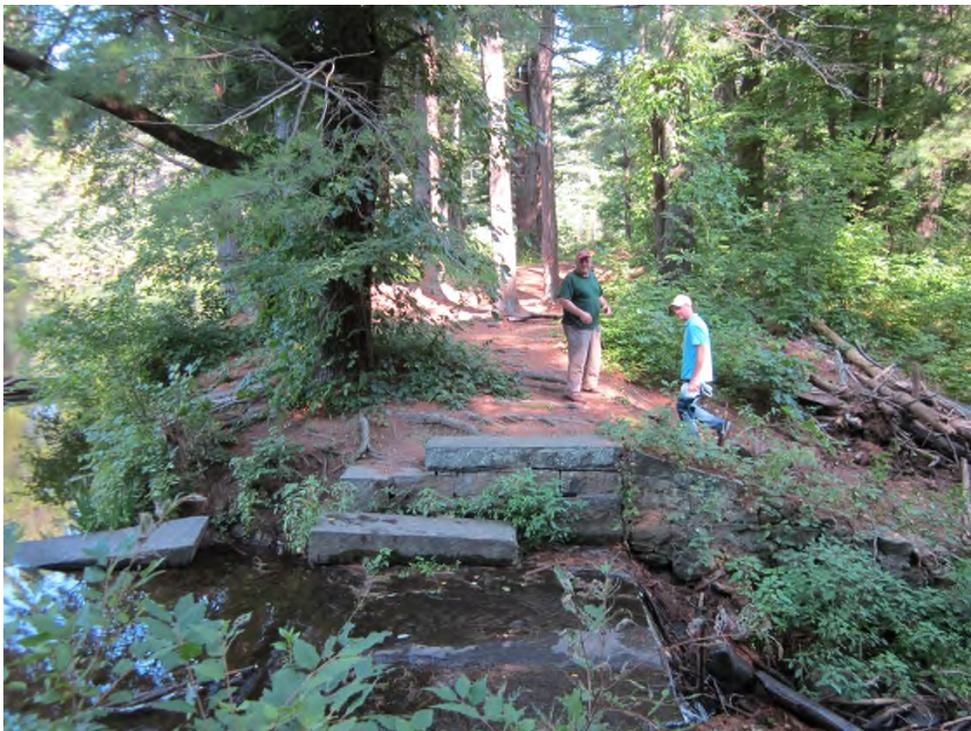
Photo 6 - Left Spillway training wall

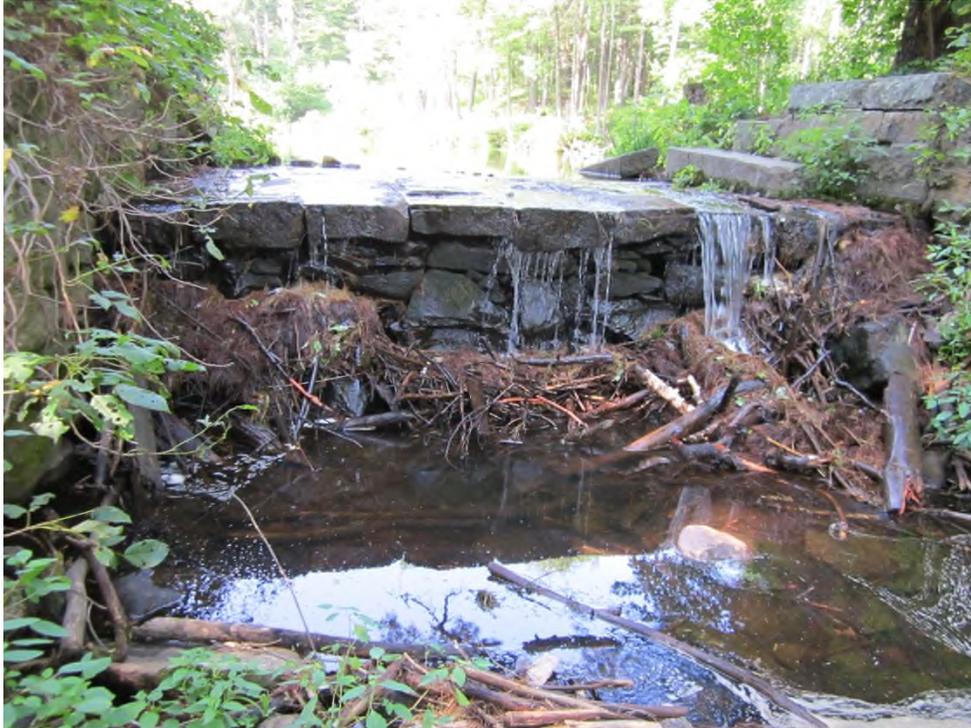
Photo 7 –Downstream view of spillway

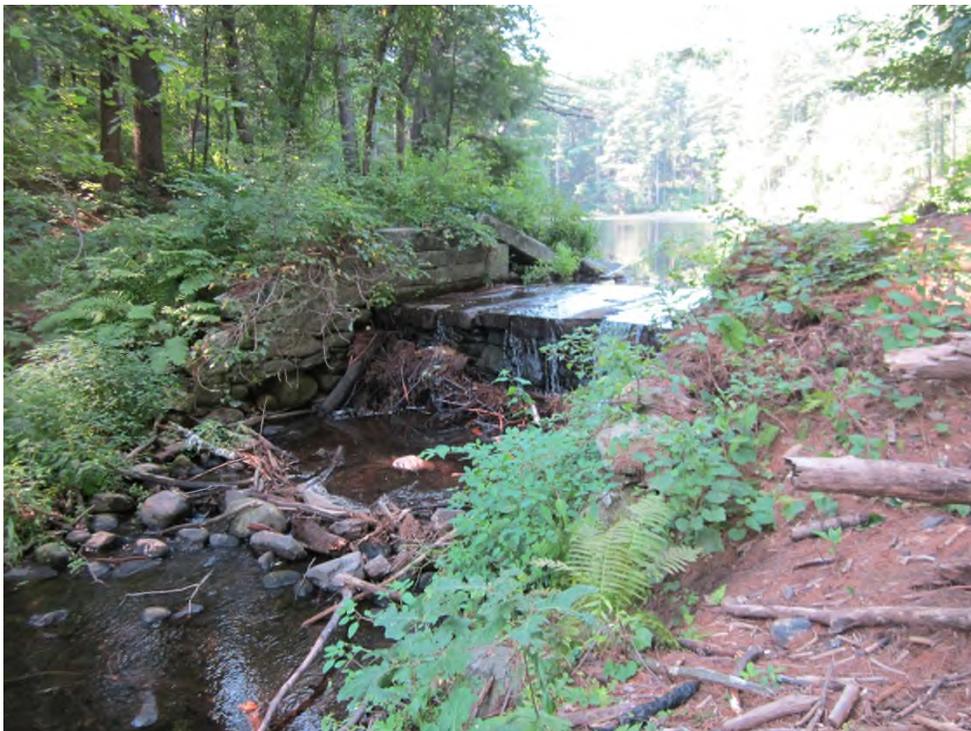
Photo 8 – Downstream view of right training wall
